Contract #: 04-0120F4Cty: SF/ALA Rte: 80 PM: 13.2/13.9File #: 1.28**WELDING INSPECTION REPORT****Resident Engineer:** Casey, William**Address:** 333 Burma Road**City:** Oakland, CA 94607**Report No:** WIR-028857**Date Inspected:** 13-Dec-2012**Project Name:** SAS Superstructure**OSM Arrival Time:** 700**Prime Contractor:** American Bridge/Fluor Enterprises, a JV**OSM Departure Time:** 1730**Contractor:** American Bridge/Fluor Enterprises, a JV**Location:** Job Site**CWI Name:** Andrew Keech**CWI Present:** Yes No**Inspected CWI report:** Yes No N/A**Rod Oven in Use:** Yes No N/A**Electrode to specification:** Yes No N/A**Weld Procedures Followed:** Yes No N/A**Qualified Welders:** Yes No N/A**Verified Joint Fit-up:** Yes No N/A**Approved Drawings:** Yes No N/A**Approved WPS:** Yes No N/A**Delayed / Cancelled:** Yes No N/A**Bridge No:** 34-0006**Component:** SAS Tower**Summary of Items Observed:**

WELDING INSPECTION REPORT

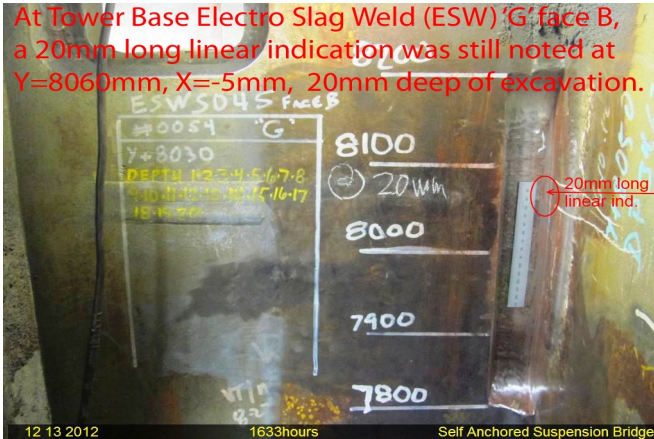
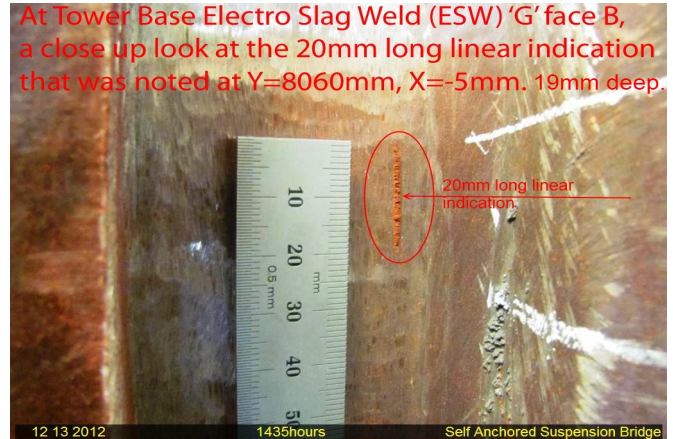
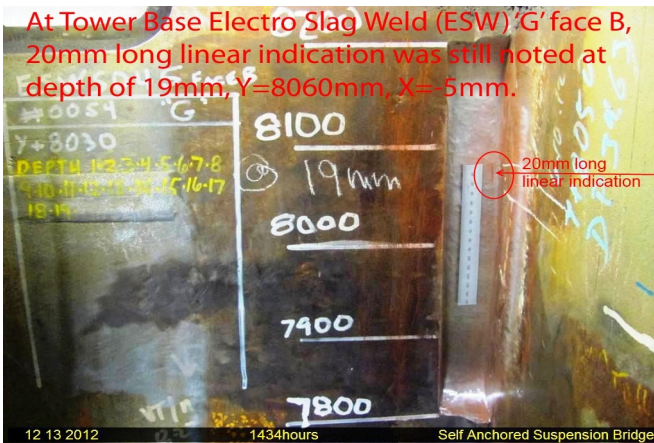
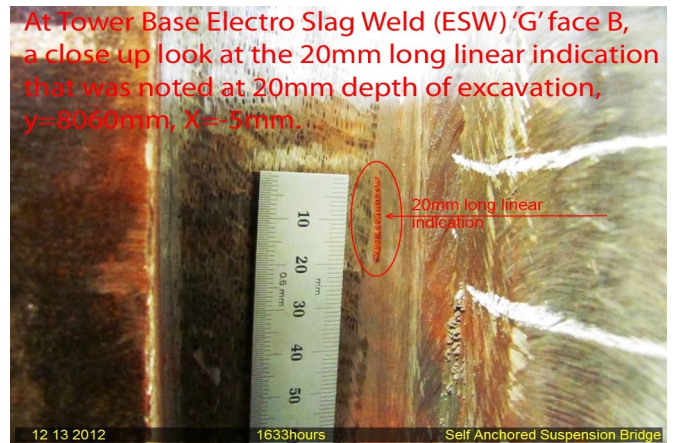
At Tower Base Electro Slag Weld (ESW) 'G' weld joint #S-045 face B, ABF personnel was observed continuing to perform exploratory excavation on welded ESW at location Y=8030mm due to UT detected defect. The ABF personnel have resumed the exploratory excavation from 19mm deep where fellow QA William Clifford has turned over the observations due to other assignment at Pier 7. The personnel were noted using only the disc grinder in every 1mm increments of excavation. ABF QC Andrew Keech was observed performing Magnetic Particle Testing (MT) on the following various depths with one noted linear indication. This QA also performed the same test and noted same result. During the shift, the ABF personnel continued the excavation in 1mm increments using the same method of test and verification up to 33mm with same result. The shift was completed up to this depth of excavation.

The starting depth of excavation on this date was a continuation from the previous shift. The results of the exploratory excavations are as follows;

1. 19mm in depth – one 20mm long linear indication noted.
2. 20mm in depth – one 20mm long linear indication noted.

At Tower Base Electro Slag Weld (ESW) 'V' weld joint #W-043 face B, ABF personnel was observed continuing to perform exploratory excavation on welded ESW at various Y locations; Y=1030mm, Y=1055mm, Y=1090mm, Y=1100mm and Y=1130mm due to UT detected defects. The ABF personnel have resumed the exploratory excavation at 63mm deep wherein ABF QC Jesse Cayabyab wants the width of the weld cover (35mm wide) to be the same width at the bottom of the excavation at 63mm. The width of the excavation at 63mm deep was originally measured at 25mm. The personnel were noted using only the disc grinder in widening the width of the excavation. At the end of the shift, widening of the excavation was still in progress and should remain tomorrow.
